Installation Instruction

Short Shifter for an MX-5 Type NB

NB0-7000

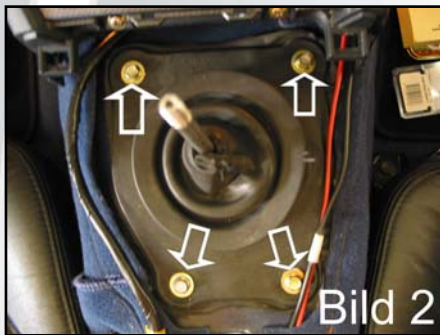
Remove the gear shifter knob and dismantle the tunnel console by removing 5 screws (see picture 1).

Now the upper shift boot is visible and can be lifted by removing 4 screws (see picture 2)
The lower shift boot can then be lifted by removing 3 screws and removed along with the gear shifter and rubber seal (see picture 3)

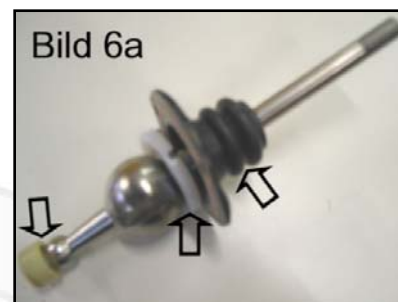
After removing and cleaning the gear stick, you can separate the stick from the rubber cuff by cutting the white plastic ring (see picture 5a)

Now the plastic bearing holder on the small ball is forced away and installed onto the short shifter.

Lay the white plastic bearing holder with washer on the short shifter ball and press on the new rubber seal (see picture 6a).

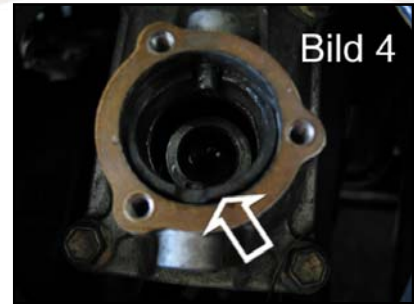
Before reinstalling the gear stick, remove the now visible plastic bearing holder and discs using a small screwdriver (see picture 4)

The plastic bearing in rule will pry off destroyed.
A new plastic bearing is contained in the scope of supply.

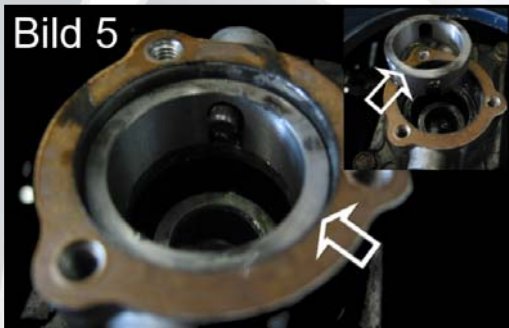
Now insert one of the new discs and push in the spacer (see picture 5)
After the spacer comes the second disc, and the plastic bearing holder (see picture 6)

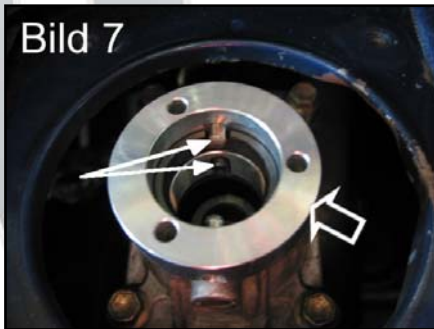
Lay the paper gasket on the seal surface and attach the distance flange. The pin needs to be adjusted so that it is above the original pin in the recess of the plastic bearing holder (see picture 7)
Place the short shifter perpendicular to the transmission so that the pin slides into the bearing recess.
Fasten the seal sleeve using the supplied screws. (see picture 9)

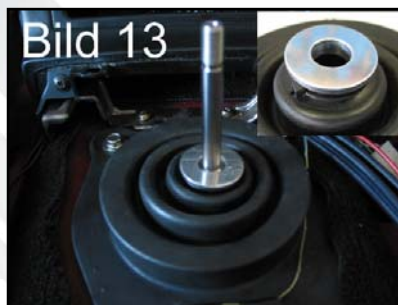
Now fasten the plastic ring using a cable tie onto the rubber seal. Screw the seal back on (see picture 13).
